Arboricultural Planning Report

Impact Assessment and Method Statement

Site: Land at Cuffley Hill
Goffs Oak
Waltham Cross
EN7 5EU

Reference: TCTC-21217b

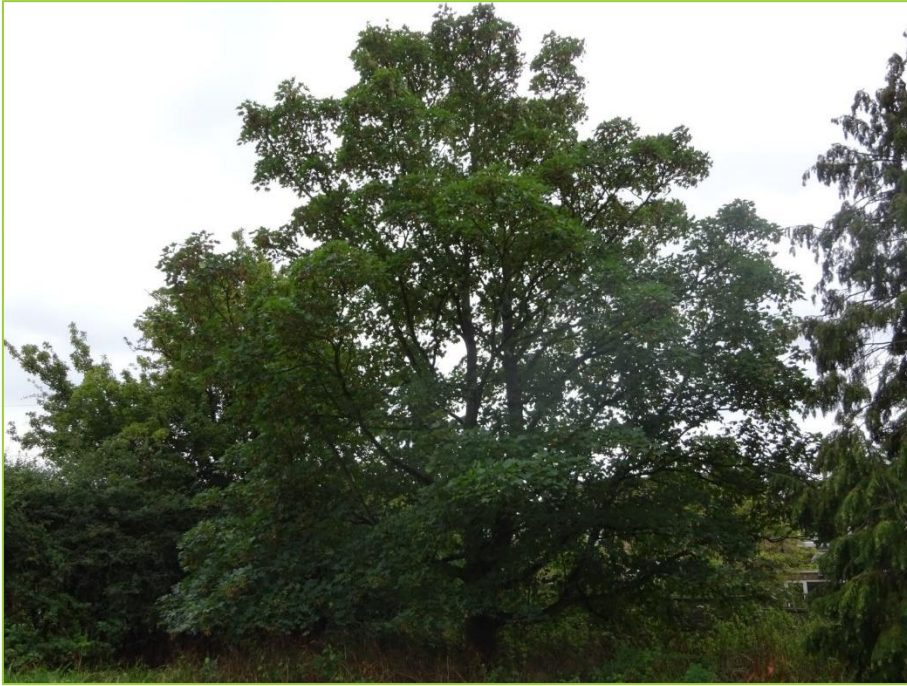
TC1. (18.08.2018) T2 sycamore to be removed – viewed south

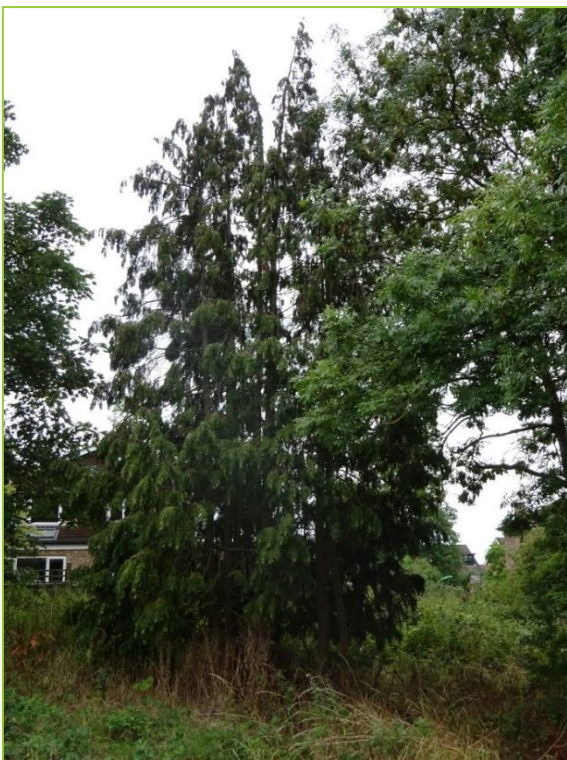
TC2. (18.08.2018) T3 cypress to be removed – viewed south

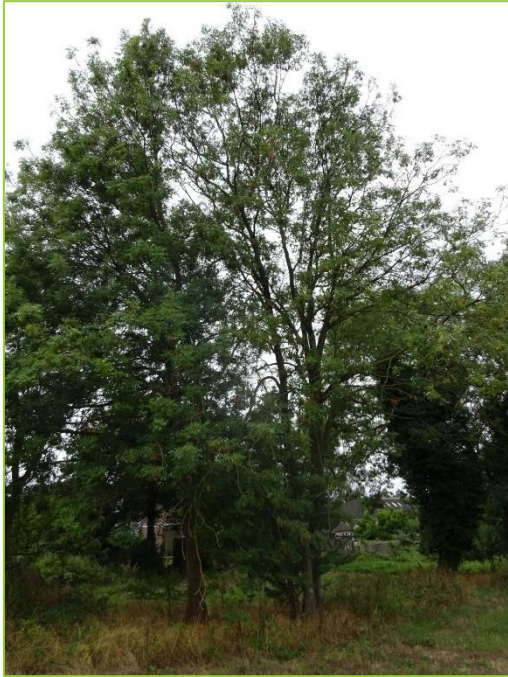
TC4. (18.08.2018) T5, T6 ash trees to be removed – viewed south

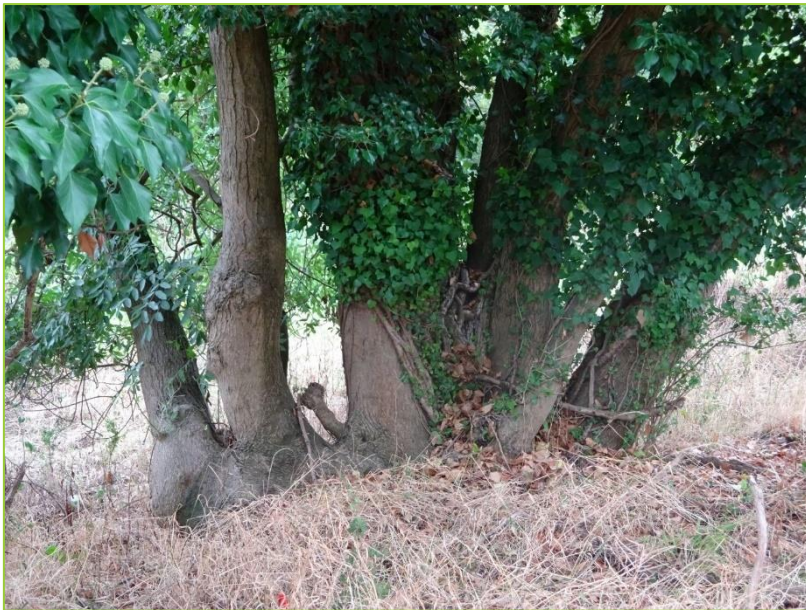
TC5. (18.08.2018) T12, coppice stool of ash to be removed – viewed north

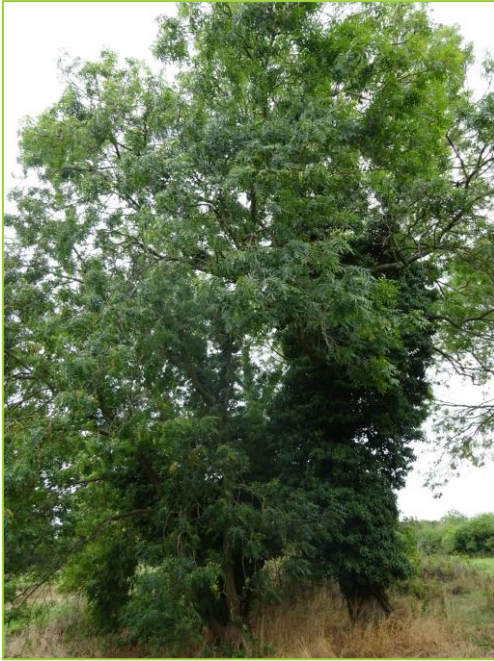
TC6. (18.08.2018) T17, T18, T19 ash and oak for removal – viewed north

Tree T19	1 Fraxinus excelsior (Ash)	19.0	81	1	11.2		11.3		11.9		11.8		3.0		Mature	Structural condition Fair. Physiological condition Fair. Deadwood - Major. Deadwood - Minor. Pruning wounds - Decayed. Shedding limb / limbs - Historic. Shedding limb / limbs - Major. Thin crown	18/08/2018	296.8	9.7	10-20	C1

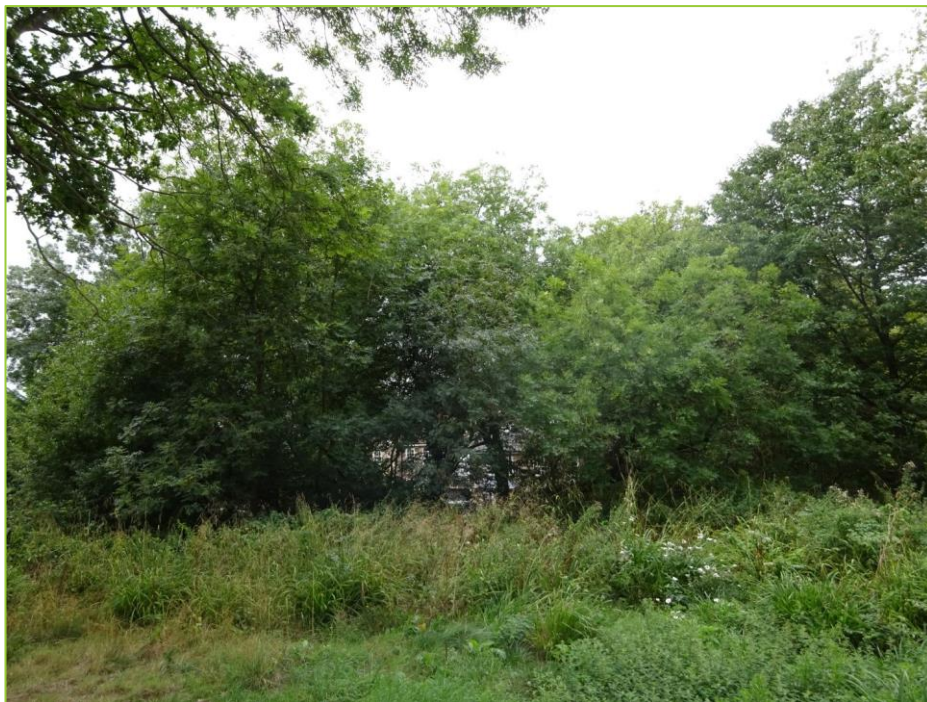
TC7. (18.08.2018) View from within the site of T24, T25 west boundary trees

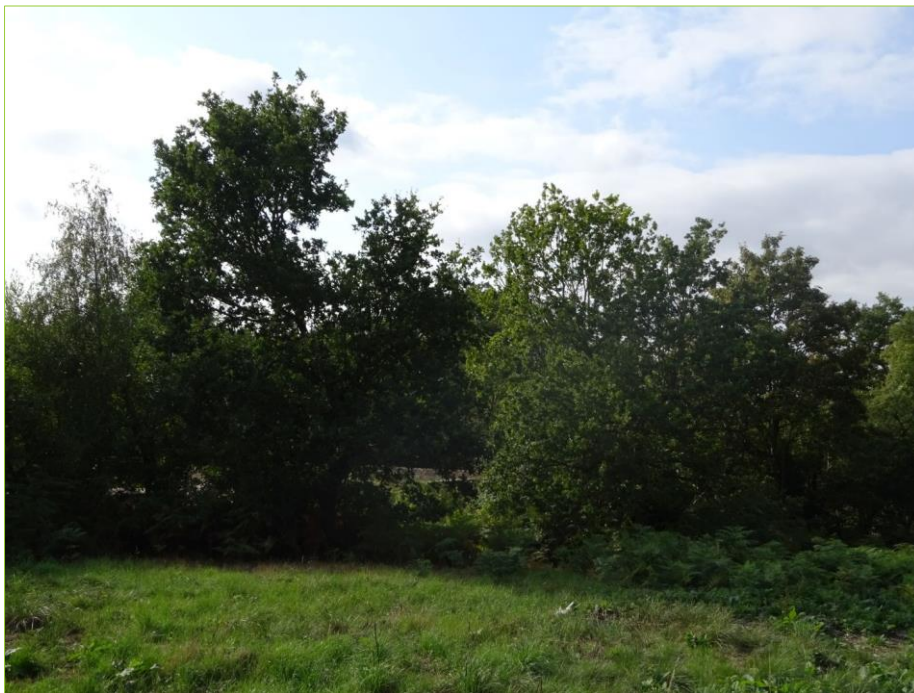
TC9. (18.08.2018) View of western boundary hedgerow / group G56 – to be retained and slightly pruned back
