**LAND NORTH OF CUFFLEY HILL,
GOFFS OAK, EN7 5EX**

FLOOD RISK ASSESSMENT

**REPORT REF. 162101-03B
PROJECT NO. 162101
NOVEMBER 2019**

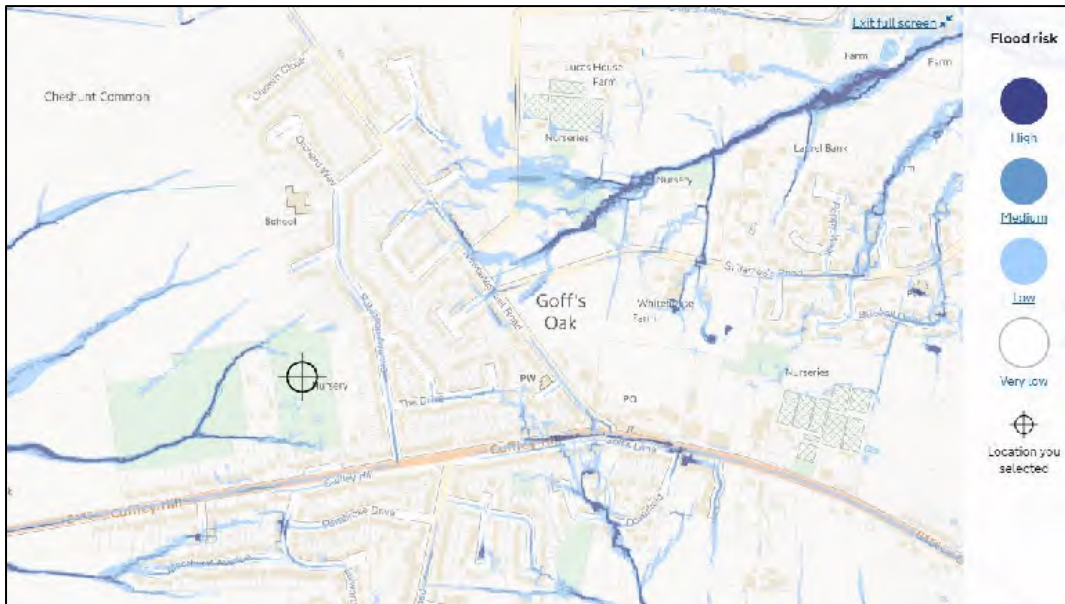
Figure 4-1: Extract of EA Surface Water Flood Mapping

- 4.8. The EA flood maps for surface water indicate that the Site is located within an area of predominantly very low risk of surface water flooding, however, there are small areas of low risk to the north and south of the site and a medium risk of surface water flooding to the south. Refer to **Figure 4-1** below.
- 4.9. The SFRA sequential test identifies a small extent of surface water flooding for the 1 in 1000 year event, however this is understood to be related to the topography of the site.

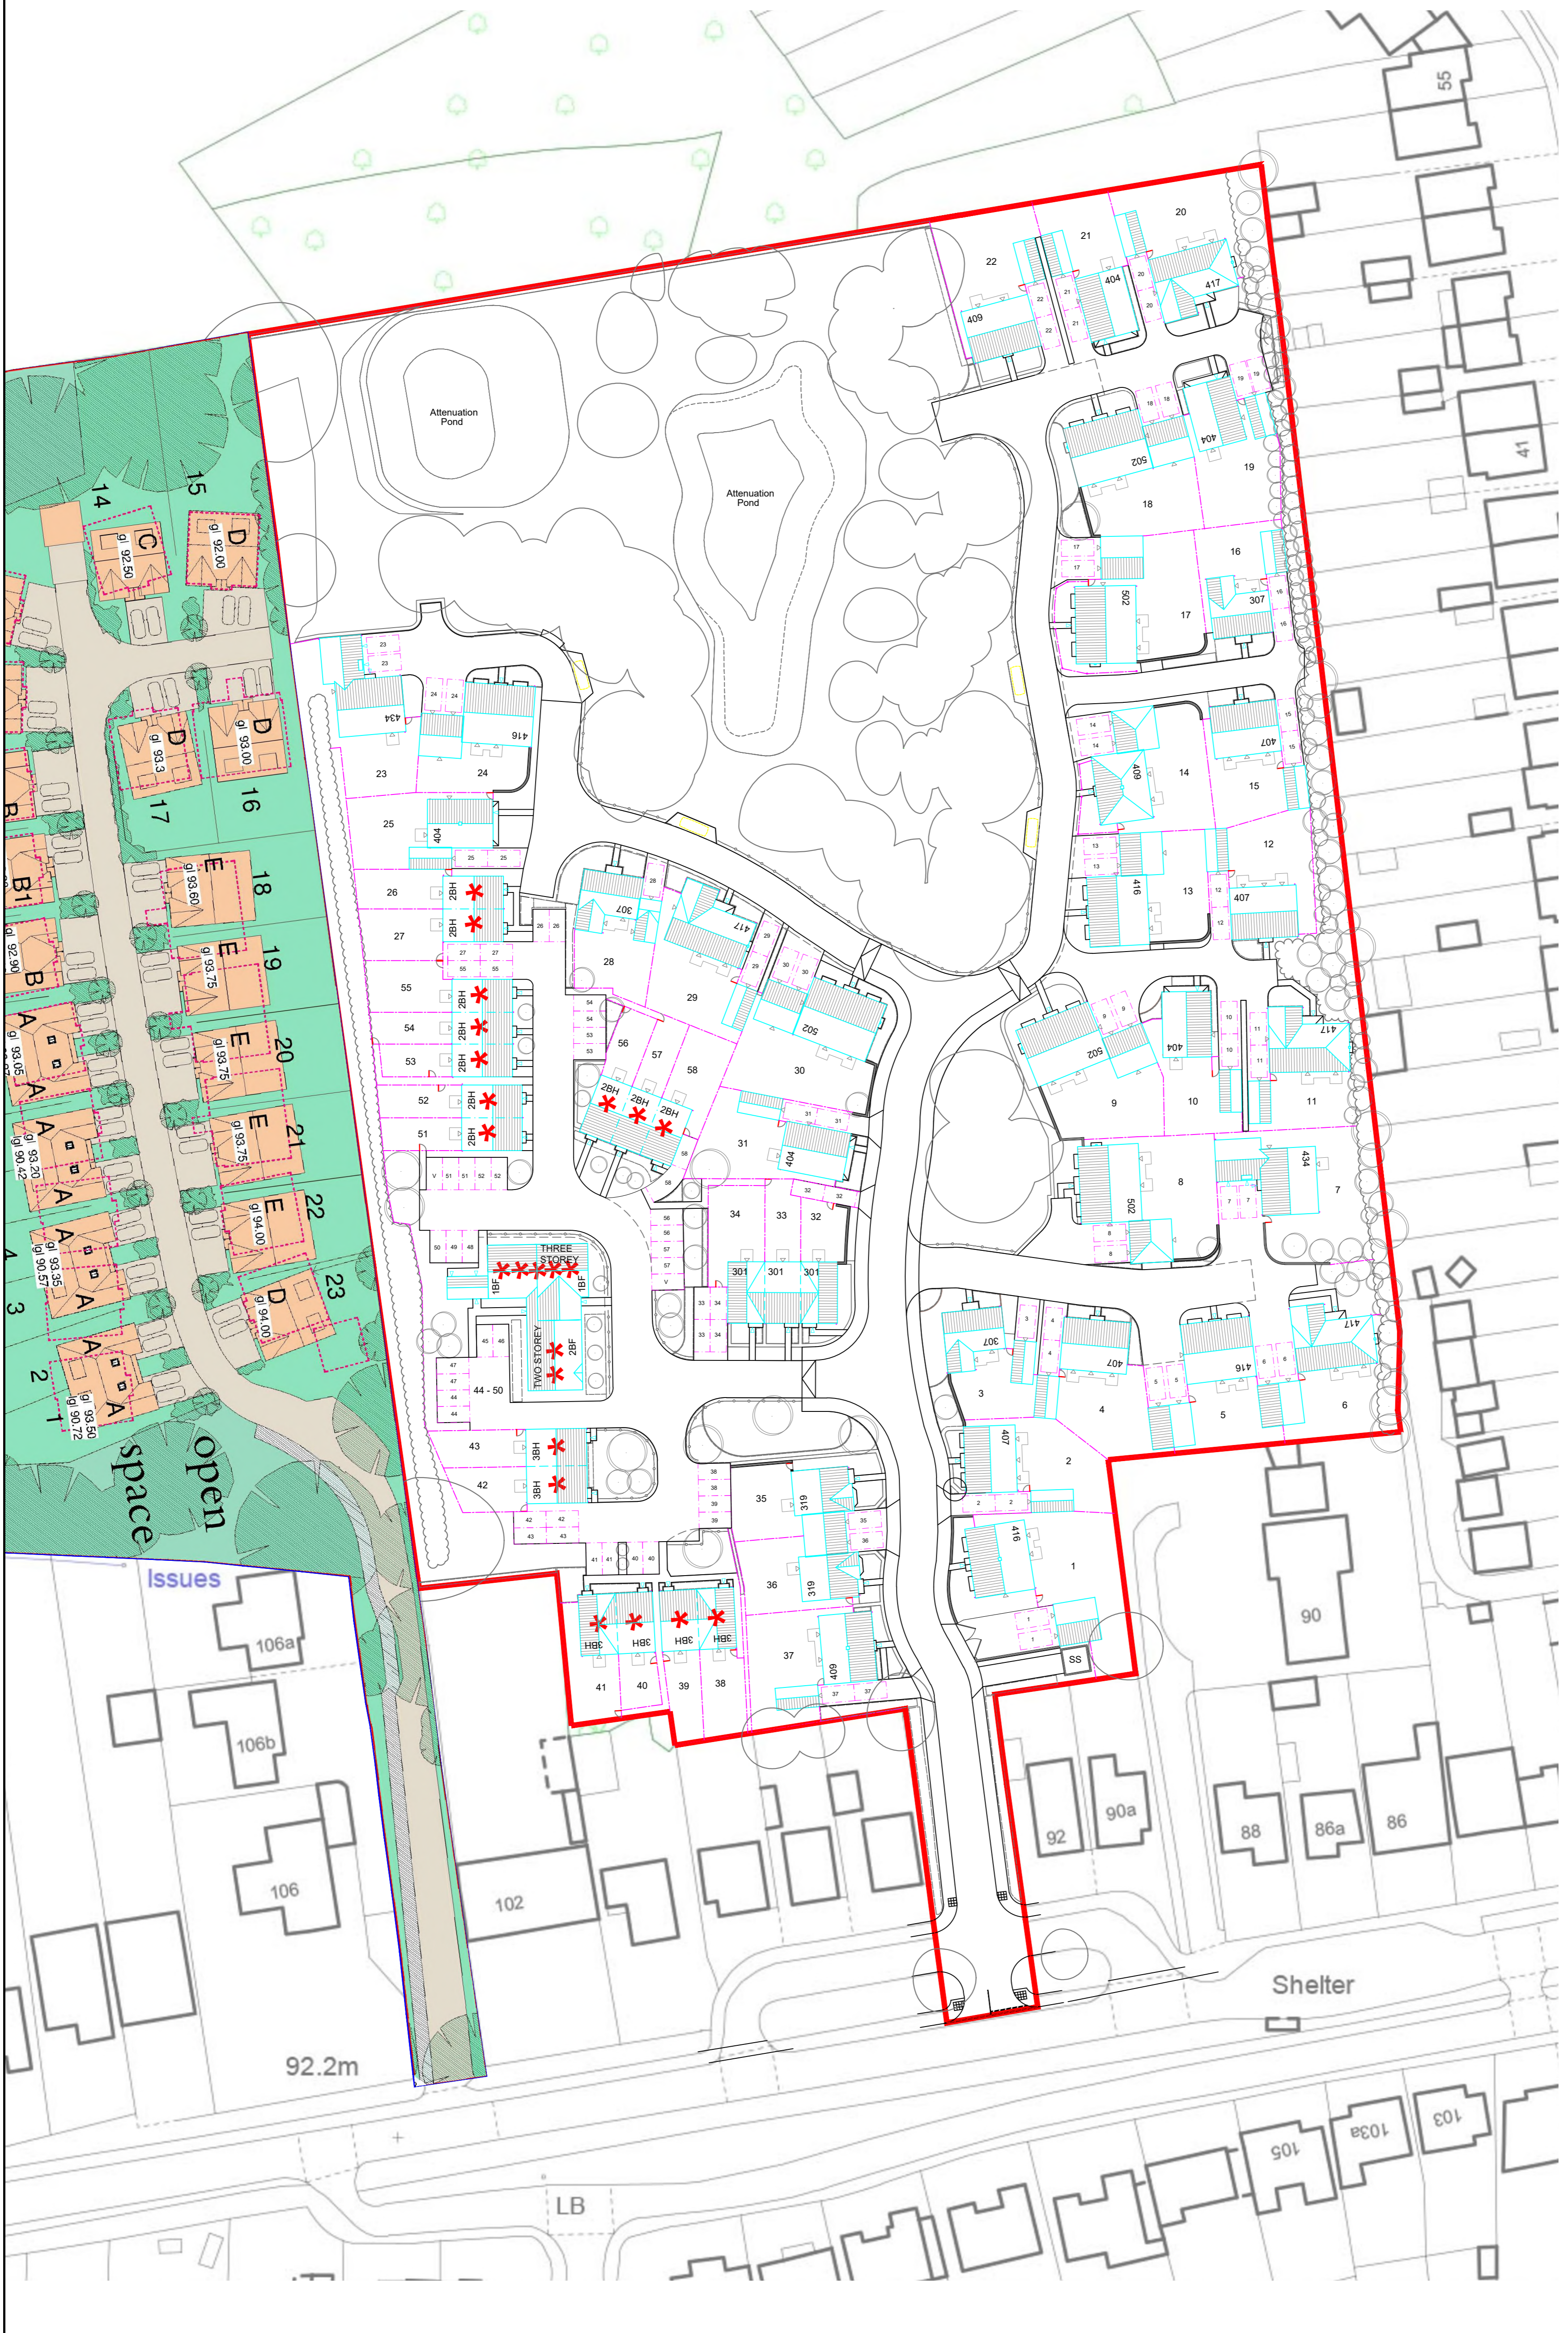
PRIVATE				
House Type	No of Bedrooms	SqFt	No	Total SqFt
301	3B	907	3	2721
319	3B	1047	2	2094
307	3B	1190	3	3570
404	4B	1281	5	6405
407	4B	1397	4	5588
409	4B	1494	3	4482
416	4B	1743	4	6972
434	4B	1784	2	3568
417	4B	1808	4	7232
502	5B	1970	5	9850
TOTALS			35	52482

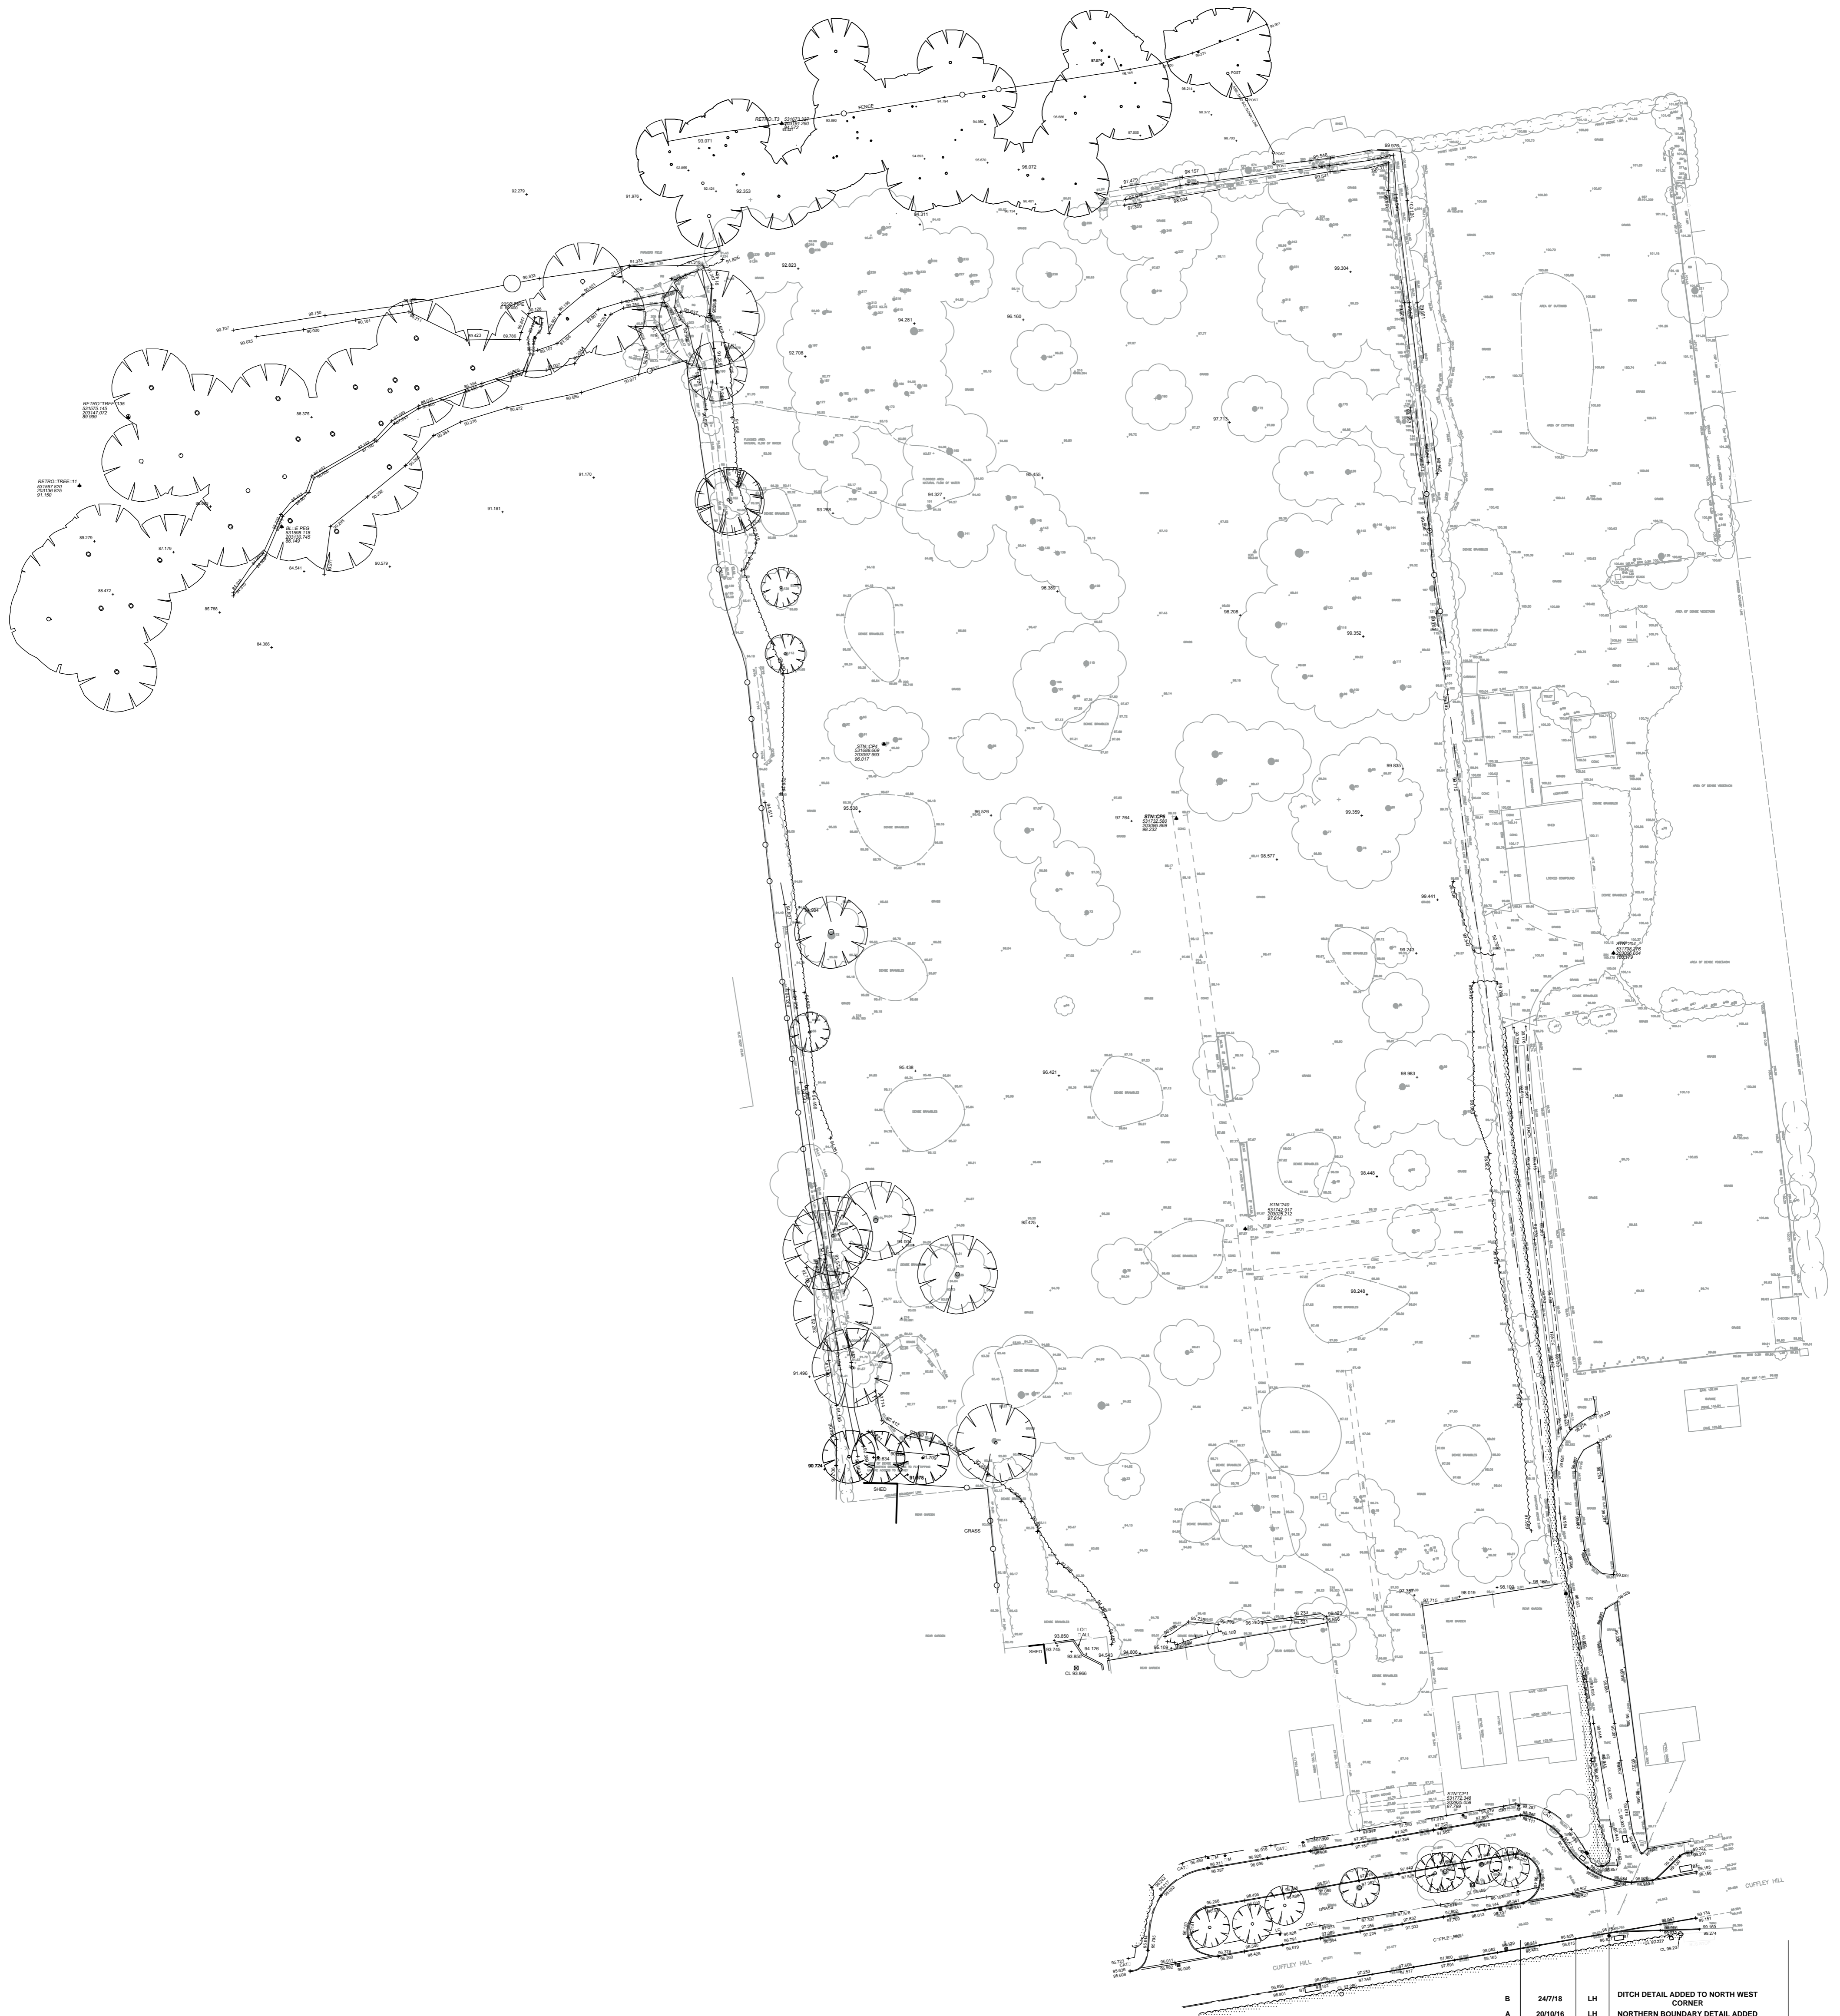
Appendix B
Topographical Survey

Rev	Date	By	Description	Chk'd
B	24/7/18	LH	DITCH DETAIL ADDED TO NORTH WEST CORNER	
A	20/10/16	LH	NORTHERN BOUNDARY DETAIL ADDED
